# Crash Test Between a 6-KG/M U-Channel Sign Support and a 1997 Geo Metro: FOIL Test Number 99F010

PUBLICATION NO. FHWA-RD-01-046

MARCH 2001

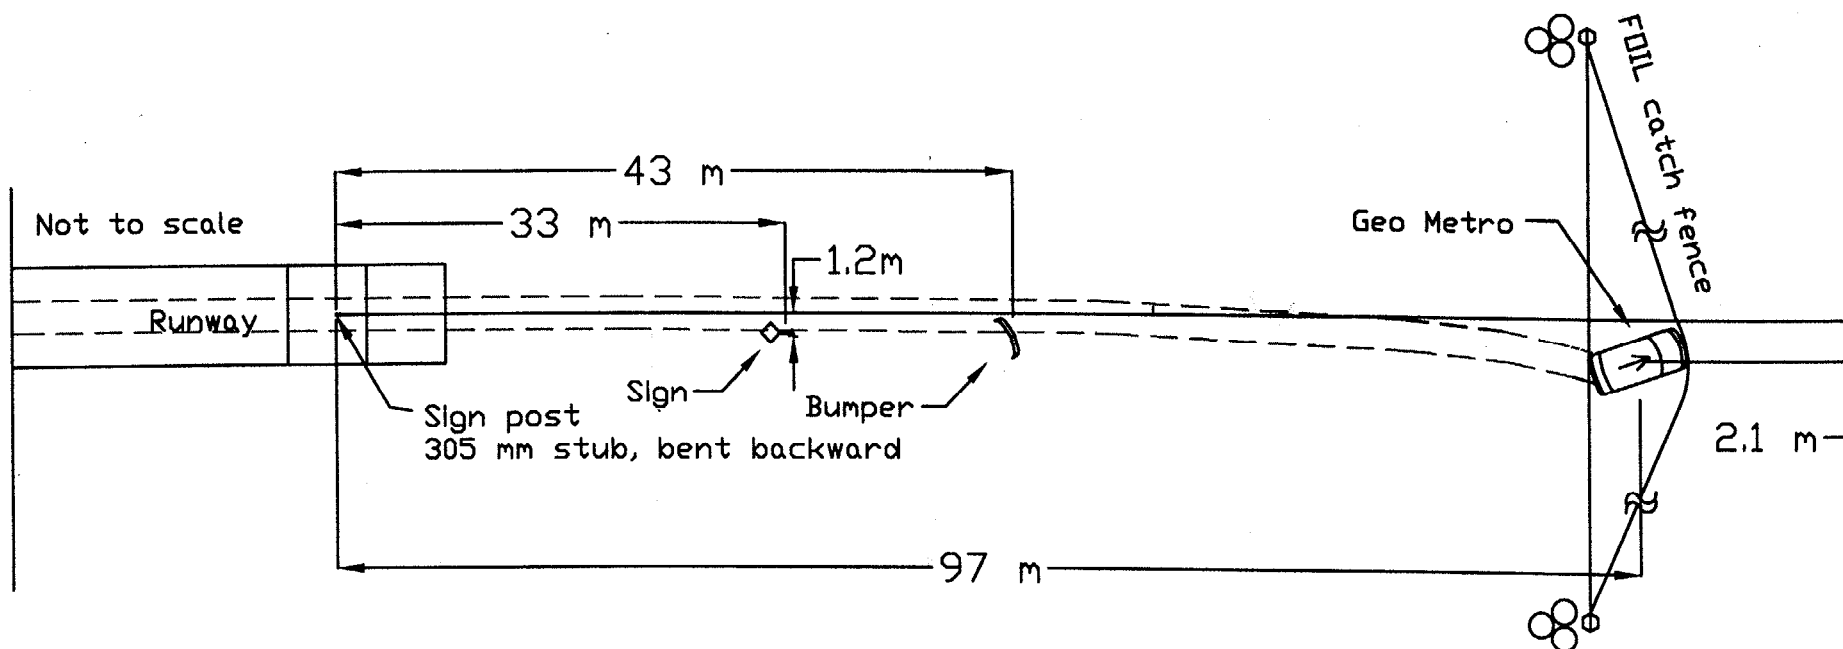
Figure 4. Summary of results, test 99F010.

The results summarized in figure 4 indicate that the 6-kg/m small sign support embedded in strong soil did not meet the safety performance criteria outlined in *NCHRP Report 350* (test designation 3-61). The sign support did fracture as anticipated and the longitudinal OIV (1.7 m/s) was below the allowable limit (5 m/s). However, the sign post contact with the vehicle caused a significant amount of denting to the roof and shattered the windshield, diminishing a driver's visibility. Table 6 summarizes the safety performance of the small sign support.

Occupant Risk:	Observed	Design/Limit
Longitudinal:		
Occupant delta V at 0.6 m.....	1.7 m/s	3/5 m/s
Ridedown acceleration.....	0.4 g's	15/20 g's
Lateral:		
Occupant Delta V at 0.3 m.....	no contact	NA
Ridedown acceleration.....	no contact	NA
Peak 50 ms acceleration:		
Longitudinal.....		3.3 g's
Lateral.....		NA
Vehicle Damage:		
Traffic Accident Data (TAD).....		12-FC-4
Vehicle Damage Index (VDI).....		12FCEN3
Static crush.....		305 mm
Post fracture.....		305 mm above ground
Exit speed.....		90.5 km/h
Exit angle.....		0.0°

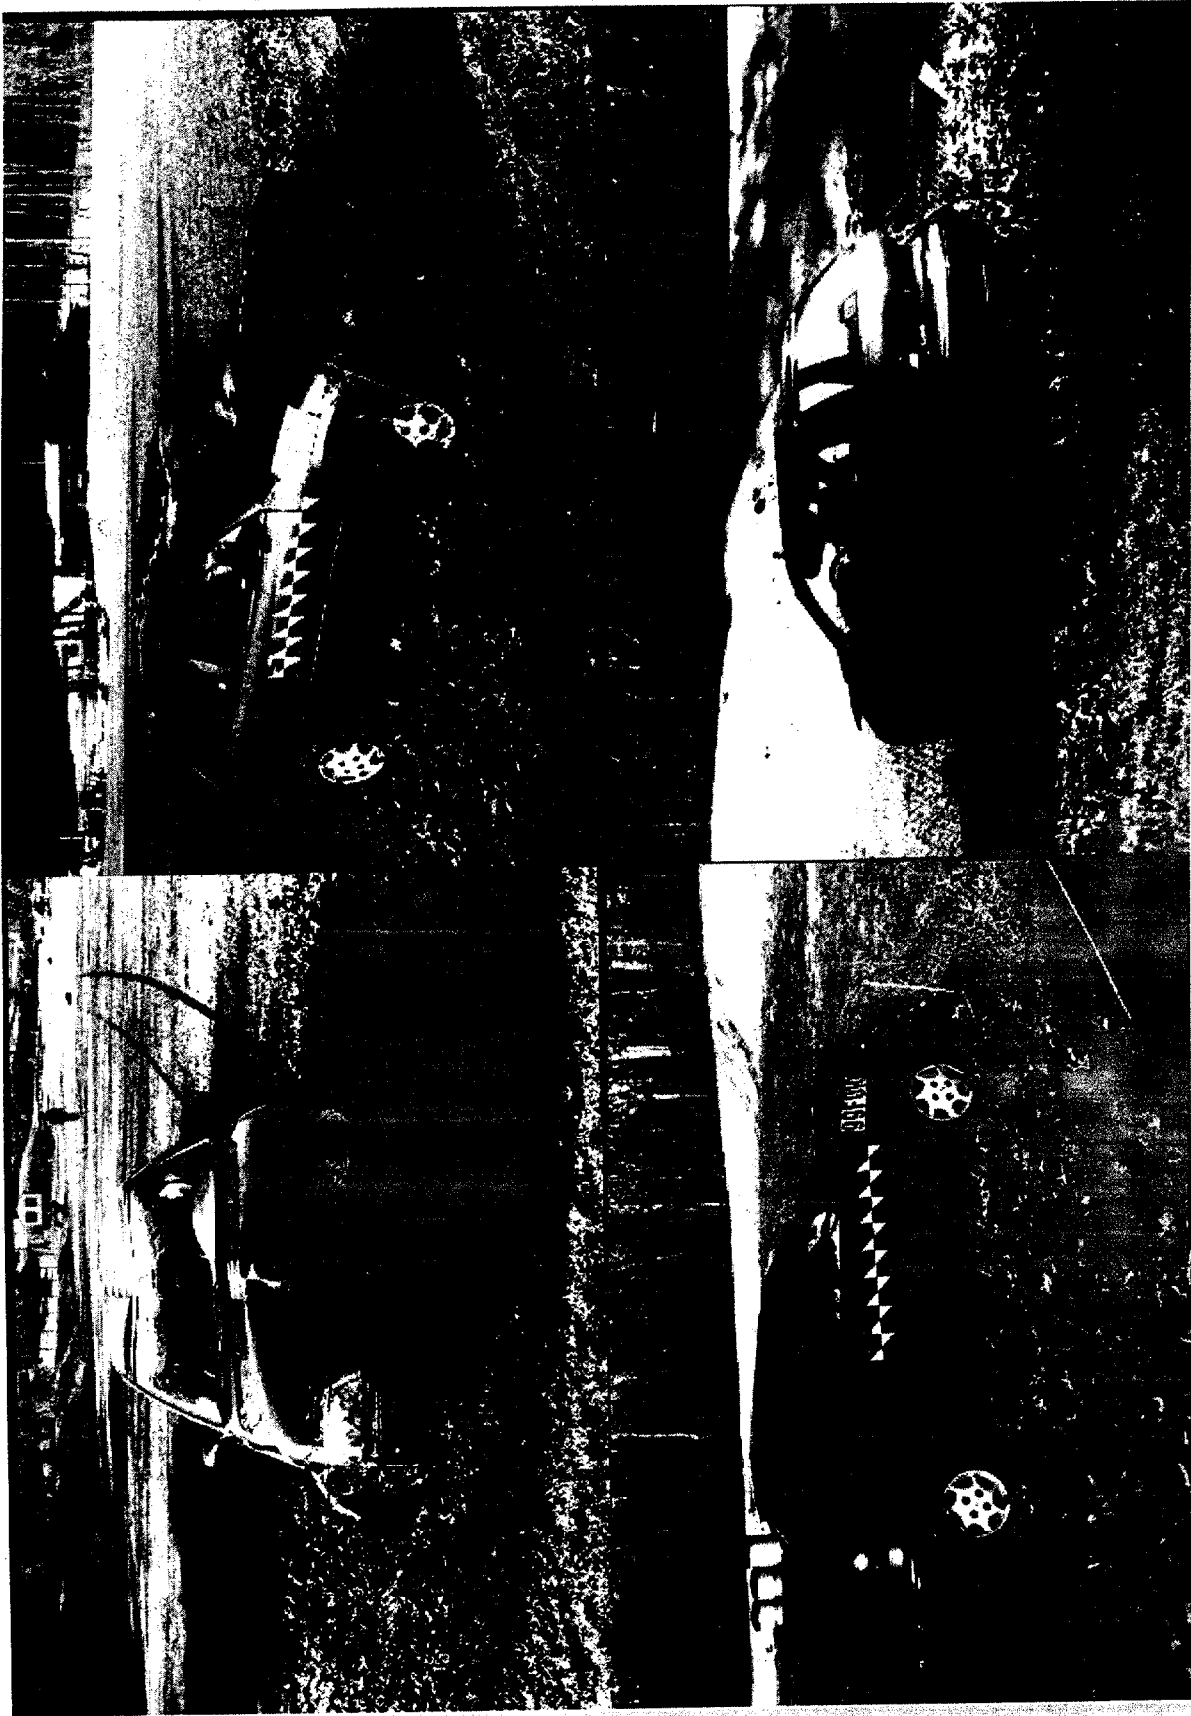
Figure 8. Post-test photographs, test 99F010.

Vehicle damage. Damage to the vehicle was extensive. The hood, roof, grill, head lights, and core supports were either crushed and/or dislodged from the vehicle. The bumper and lower front cross-member were torn from the vehicle. The windshield was shattered. Both air-bags were deployed.

Sign damage. The sign support fractured approximately 305 mm above ground. The remaining stub was bent backward and the sign

panel and post were launched downrange approximately 43 m. The trajectory of the sign post was in line with the vehicle trajectory. There was no evidence of post pull-out before fracture. The sign post could not be reused.
